ABORIGINAL CULTURAL HERITAGE ASSESSMENT REPORT – CAMERON PARK RESERVOIR AND WATER SUPPLY UPGRADE

Cameron Park Reservoir

STATEMENT OF HERITAGE IMPACT – WEST WALLSEND RESERVOIR

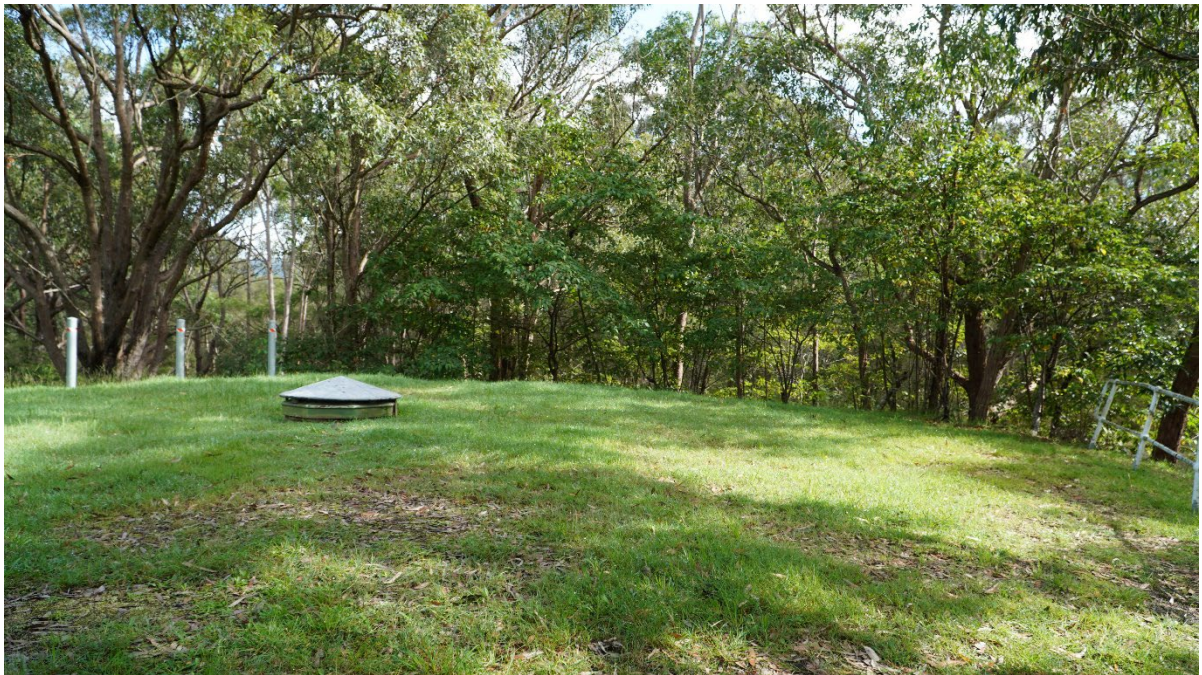
Plate 4. View north-west across the top of the underground reservoir, showing the octagonal cast-iron vent

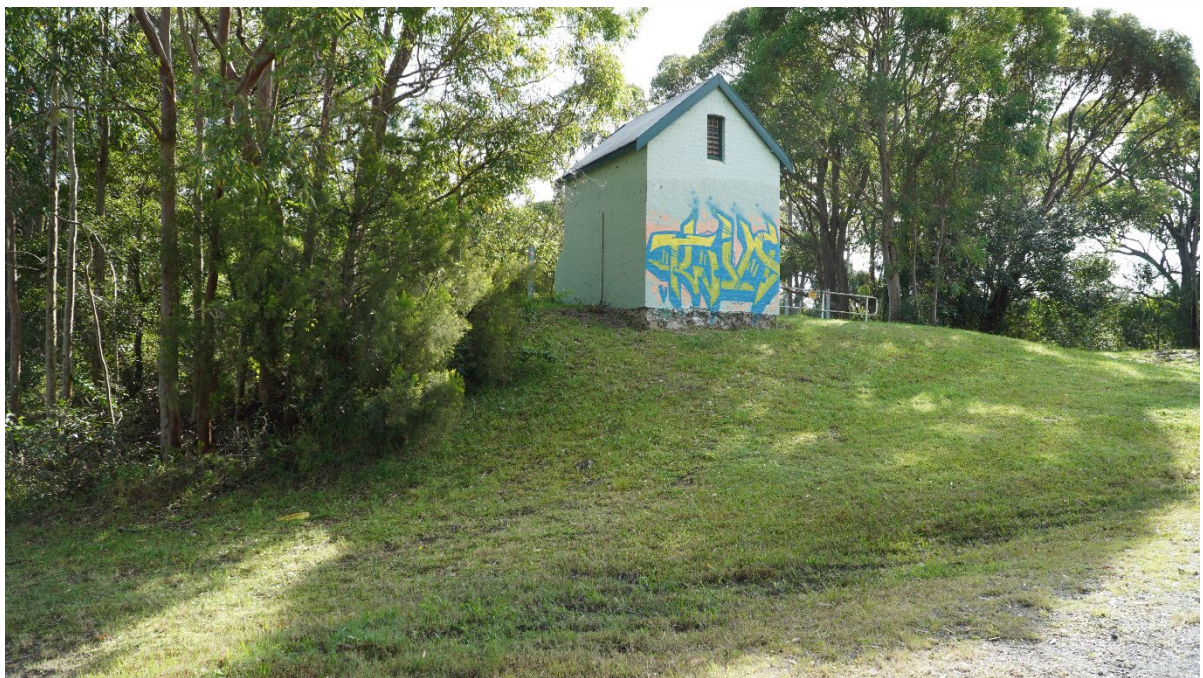
Plate 5. View north towards the valve house on the south-western edge of the reservoir mound.

The underground reservoir which is heritage listed is beneath a 20m diameter earth mound with a flat top with safety fencing and an octagonal cast-iron vent is all that is visible of the underground reservoir (Plate 4). The valve house is located on the southern edge of the reservoir cap (Plate 5).

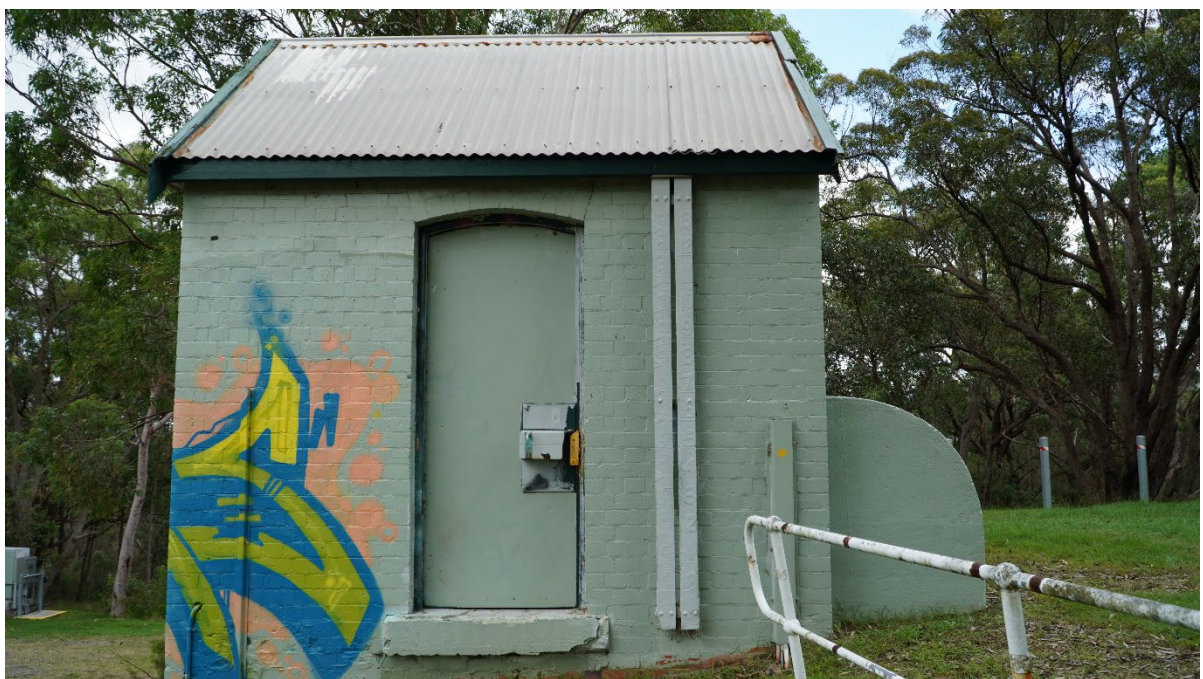
Plate 6. Eastern side of the valve house (facing west), showing entrance.

The valve house is a single-storey building made of orange/red bricks (potentially multiple types of local brick) laid in English Cross or Dutch Bond pattern (brick dimensions 233 x 110 x 15mm). The bricks have since been covered in light-green paint and graffiti. The gable roof is made of corrugated metal, and the building is situated on a concrete base. The door (on the eastern side of the building) is metal sheeted timber (not original) in the original arched timber frame, located on a sandstone base (Plate 6). Near the doorway is a depth marker, likely used to assist measuring the water level in the reservoir. The building consists of timber louvre vents 800mm H and 350mm W, with a brick arched head and raking sill of mortar are located on the north and south elevations to provide cross ventilation to the internal space. These are protected by metal mesh screens. The south side has a semi-circular headed concrete pipe encasement (measurements: 2.45m L x 1.33m H x 0.94m W) (Plate 7). Excluding this concrete structure, and concrete base (0.46m is visible out of the ground), the building is 2.93m L x >2.74m H (to the base of the vent) and 3.68m W.

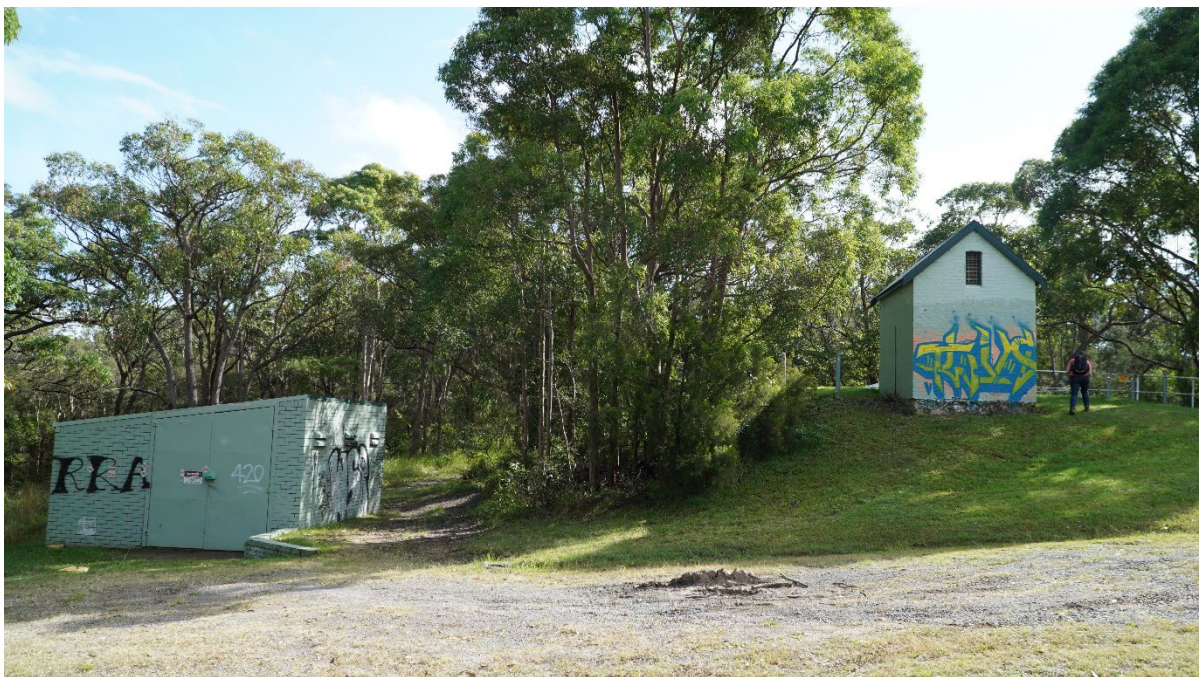
Plate 8. View north with view towards the pumping station building (left of frame) and valve house and reservoir (right of frame).

A single-story building housing the hydro-pneumatic pumping station was located 16m west of the reservoir and valve house (Plate 8). It is made of orange/red bricks laid in stretcher (running) bond pattern since covered in light green paint and graffiti (Plate 9). The skillion roof is made of corrugated metal. The building is set within an east to west slope with a small retaining wall and concrete landing on the southern side the metal entrance doors (Plate 10). There are two concrete open drains on the western side of the building (Plate 11). There are three vents on the western side of the building, 0.57m above the ground surface, and three vents on the eastern side of the building, 1.9m above the ground surface. The building is 5.86 L x 2.86 (eastern) – 3.35m (western) H and 6m W.

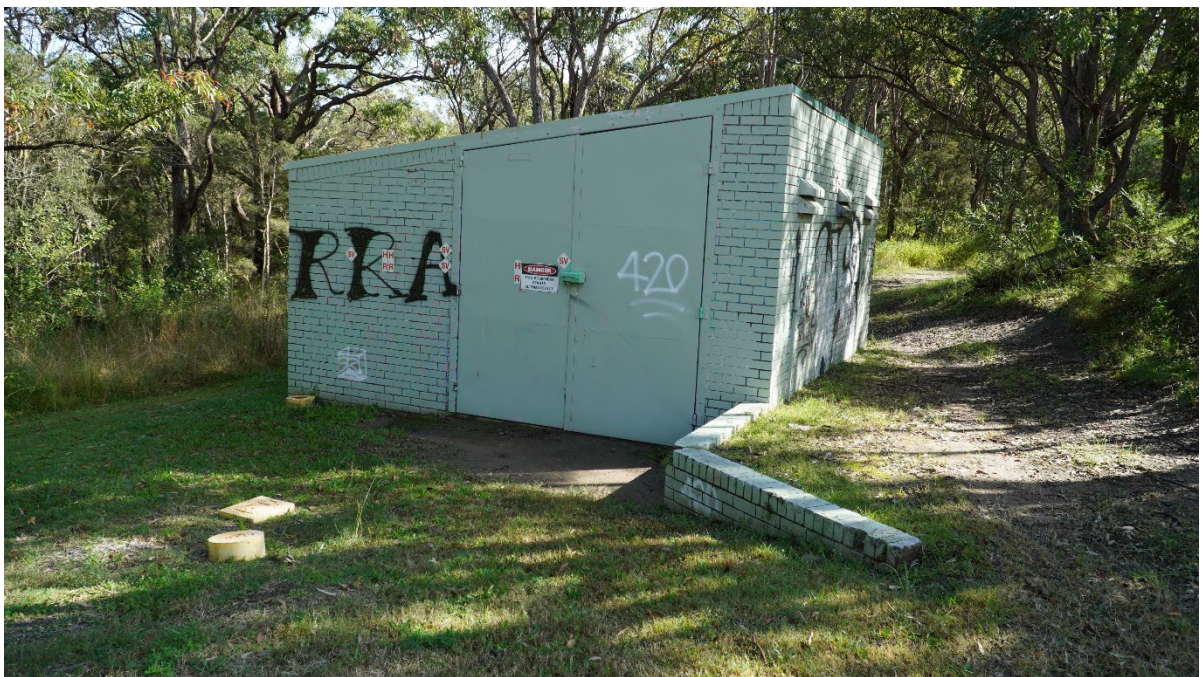
Plate 10. View of the southern side of the building, showing the concrete landing, metal entrance doors and a small retaining wall

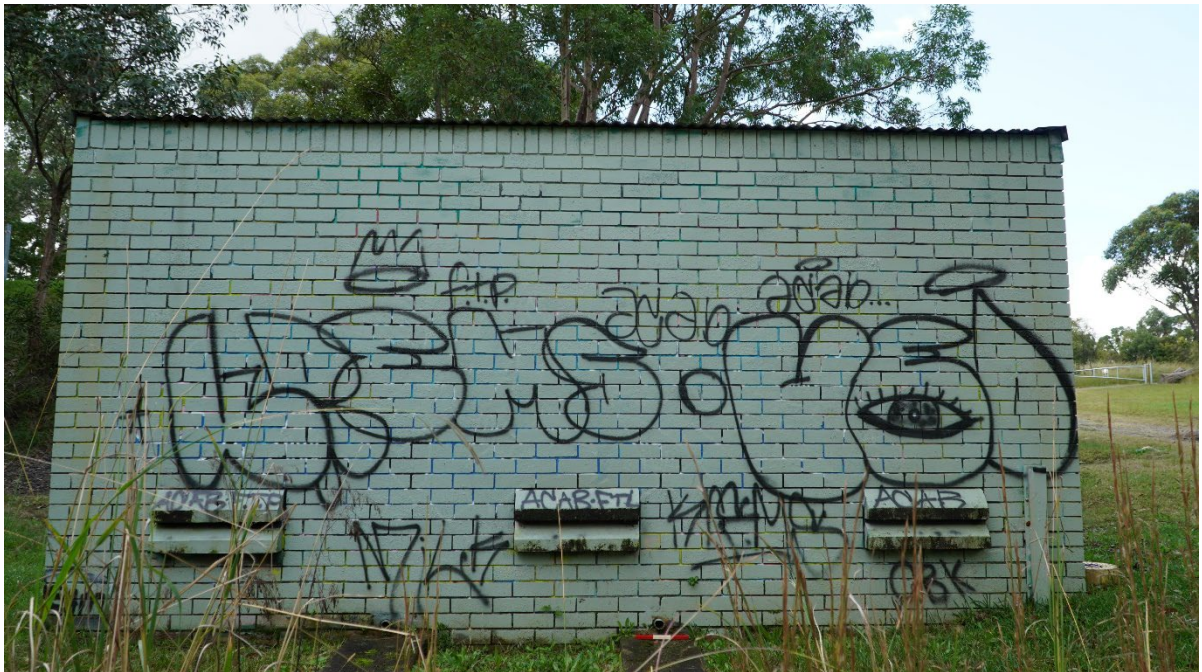
Plate 11. View of the western side of the building, showing two concrete open drains and three vents, with a 30cm scale.

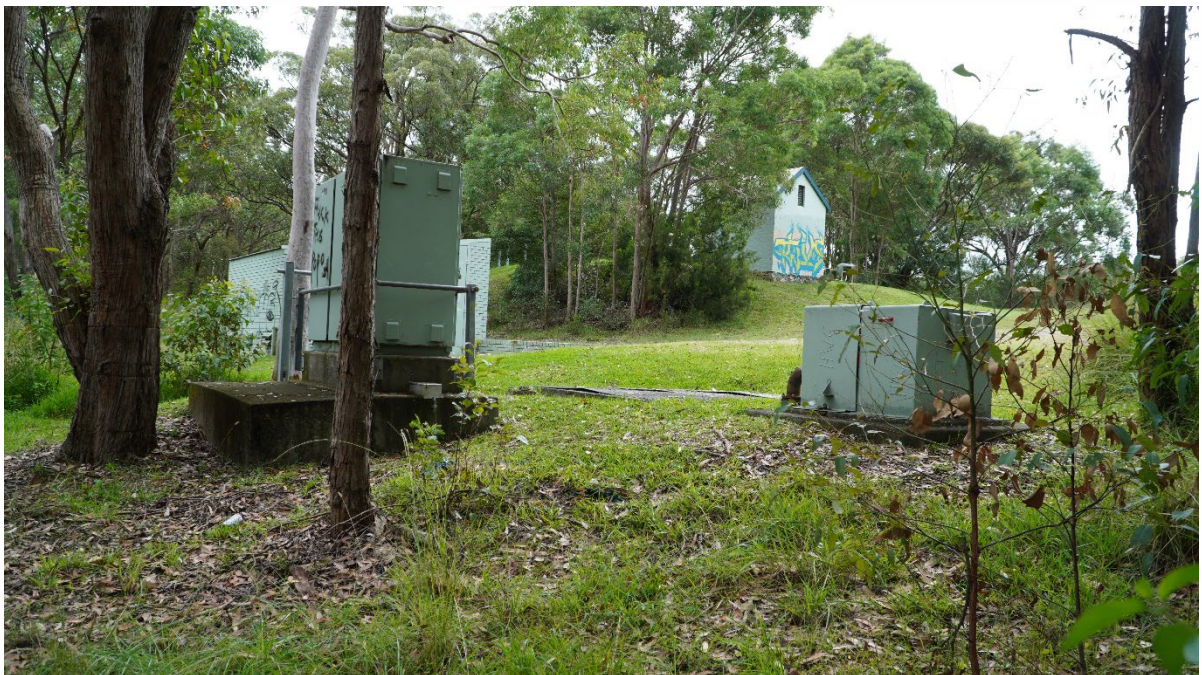
Plate 12. View north-east towards a pumping set, 15m south of the 1980s Pumping Station Building, and 30m south-west of the valve house.

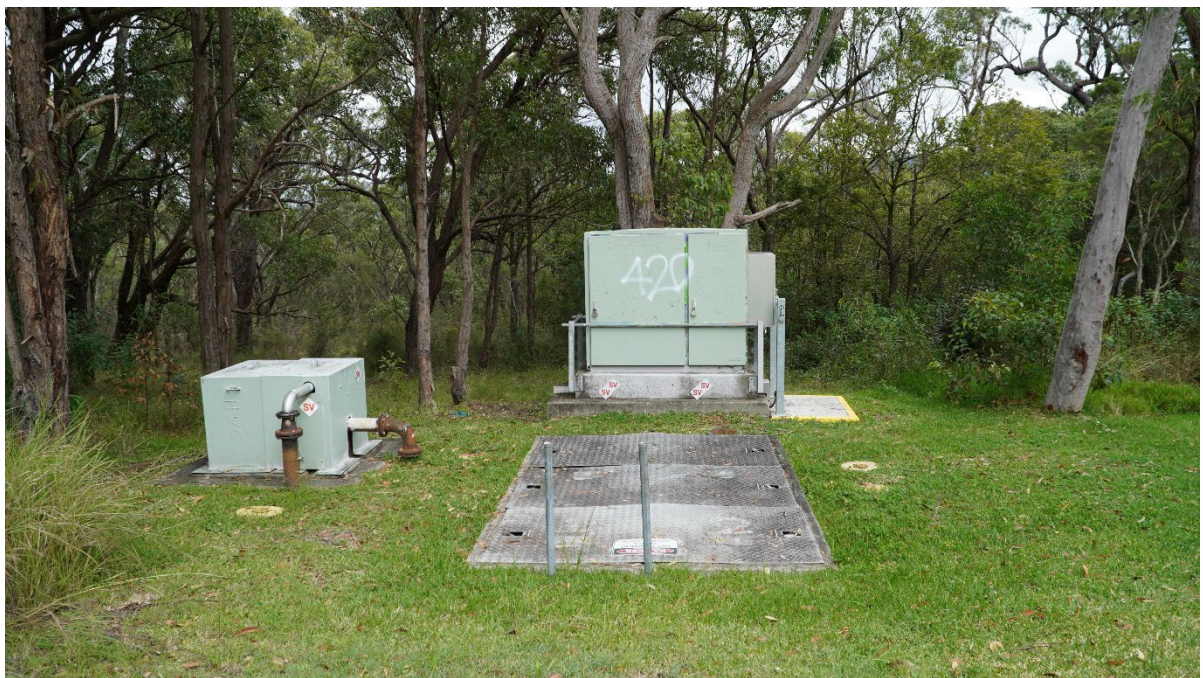
Plate 13. View south at pumping set infrastructure, including a pit covered with a metal grate.

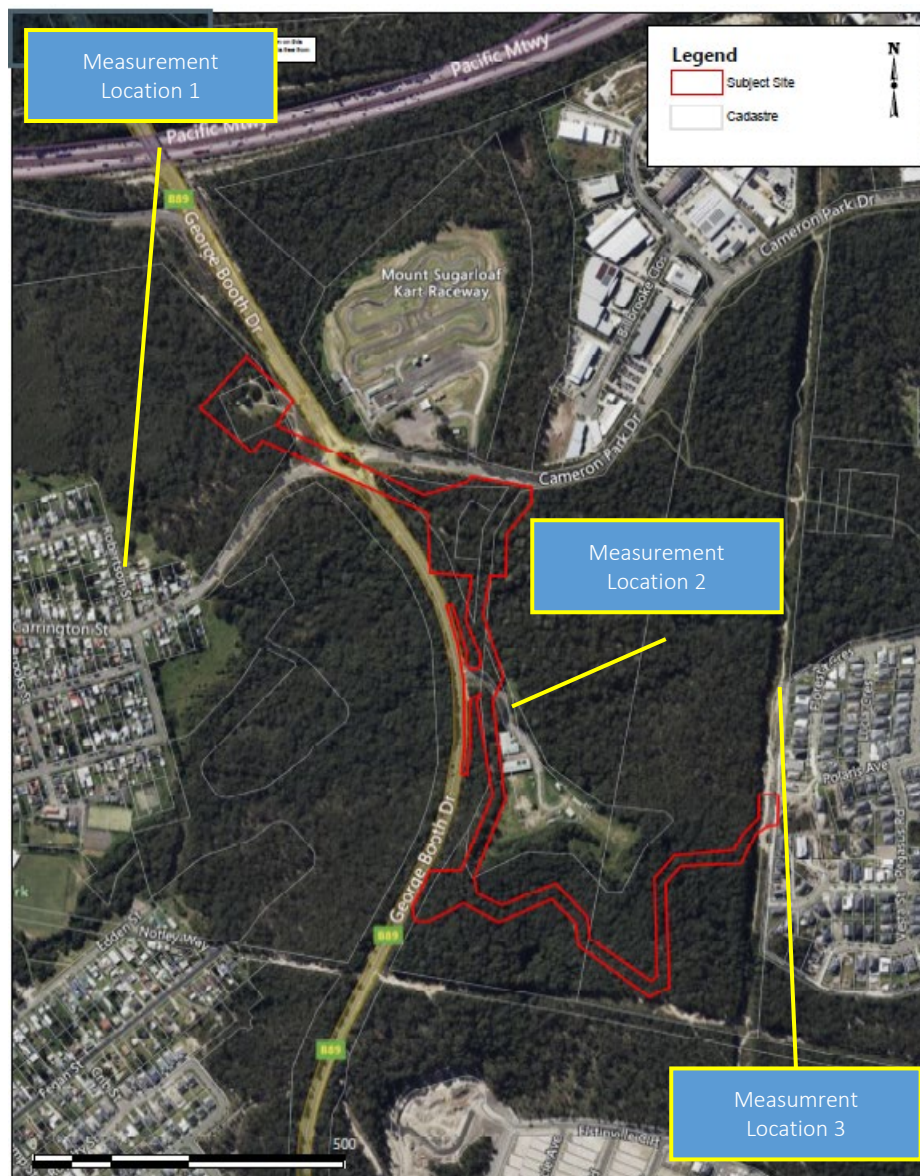
Figure 2 Location of Background Sound Level Measurements

Location 1 West Wallsend	45dB(A)
Location 2 RFS Headquarters	55 dB(A)
Location 2 Florista Crescent	35 dB(A)
